Manhole Inspection Summary

Manhole # S17K__054MH

Inspection ☐ Is Incomplete Rating: **5) Immediate Attention Required**

Location Address: **223 catherine-alley-franklin**

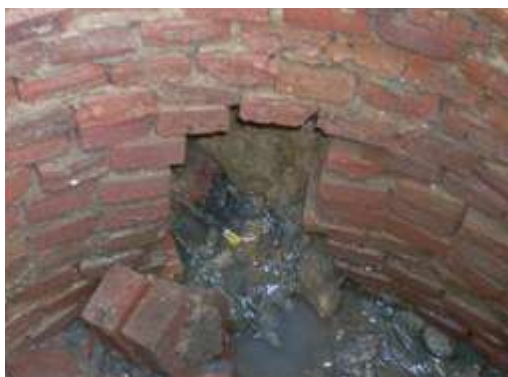
Defect 5

Manhole is in very poor condition. Could not get good measurements of the I3 and I9 pipes because they are collapsed.

deteriorated barrel, this hole is located where the I9 pipe should be.

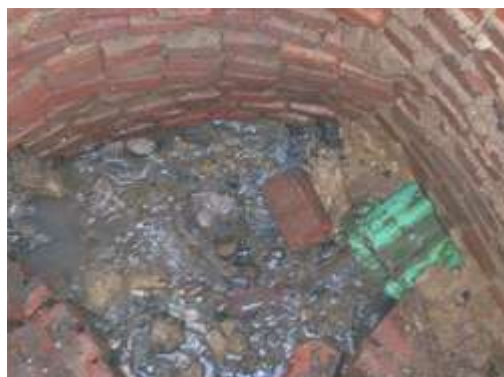
Defect 4

Condition: ☐ Sound ☐ Cracked ☐ Root Intrusion ☒ **Deteriorated** ☐ Leaks ☐ Debris

deteriorated bench

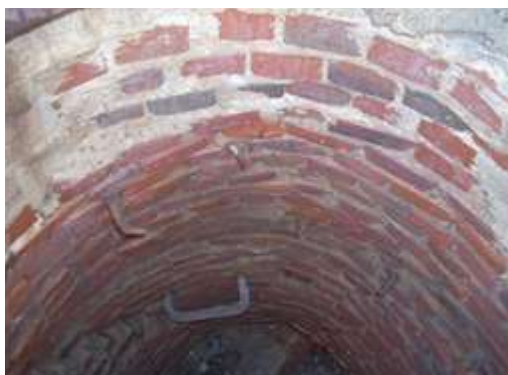
Defect 3

Count: **1** Missing: **2** ☒ **Corroded**

corroded and missing steps

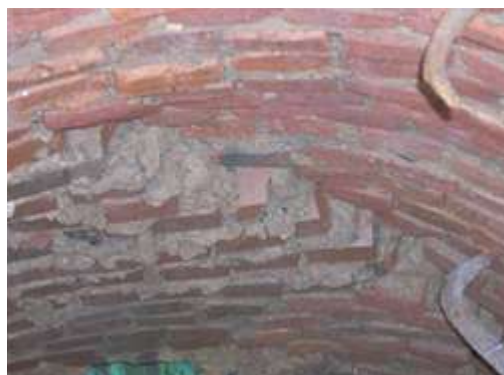
Defect 2

Condition: ☐ Sound ☐ Cracked ☐ Root Intrusion ☒ **Loose Brick** ☒ **Deteriorated**

loose barrel bricks

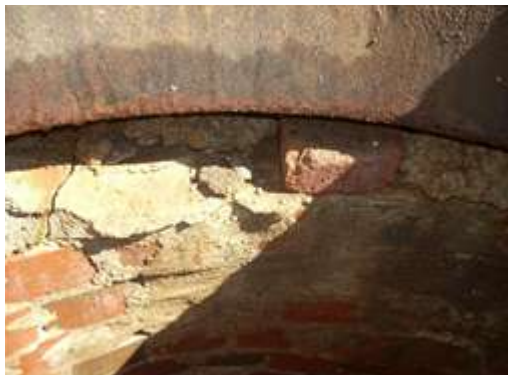
Defect 1

Condition: ☐ Sound ☐ Cracked ☐ Root Intrusion ☐ Loose Brick ☒ **Deteriorated**

deteriorated chimney

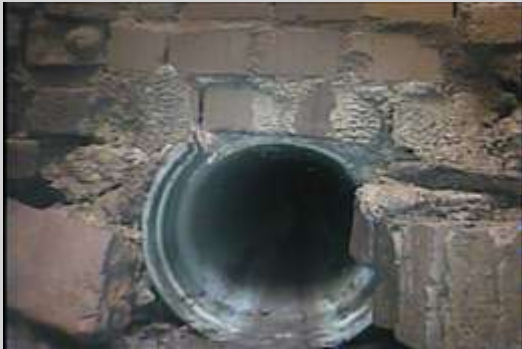
12 O'Clock Outflow

Pipe Height: **8.4** (in.) Rod and Bar (Angled)
Pipe Material: **PVC** ☐ Pipe Lined
Invert Depth: **7.44** (ft.) Flow Characteristics: **Slow**
Deposits: ☒ None ☐ **Mud** ☐ Sludge ☐ Debris ☐ Grease
Silt Depth: **0** (in.) Deposits Extent:
Infiltration: **None** Pipe Seal Cond: **Broken**

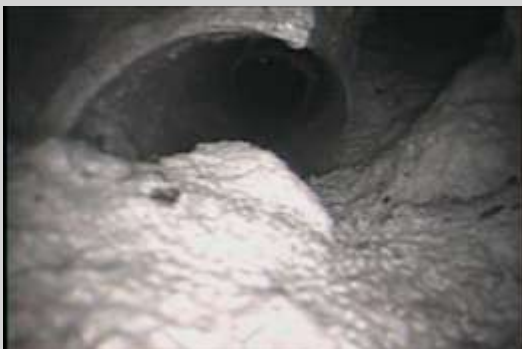
3 O'Clock Inflow

Pipe Height: **6** (in.) Rod and Bar (Angled)
Pipe Material: **Clay** ☐ Pipe Lined
Invert Depth: **7.18** (ft.) Flow Characteristics: **None**
Deposits: ☐ None ☒ **Mud** ☐ Sludge ☐ Debris ☐ Grease
Silt Depth: **4** (in.) Deposits Extent: **Heavy**
Infiltration: **None** Pipe Seal Cond: **Broken**

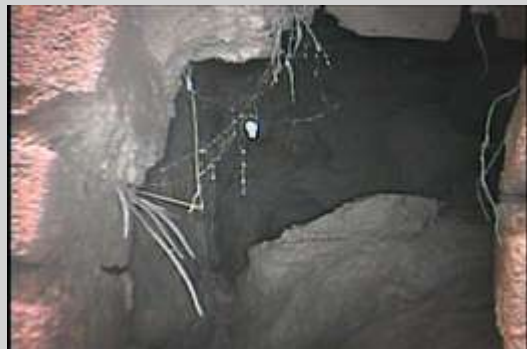
9 O'Clock Inflow

pipe is collapsed

Deposits: ☐ None ☒ **Mud** ☐ Sludge ☐ Debris ☐ Grease

Silt Depth: **8** (in.) Deposits Extent: **Heavy**
